Soil Characteristics in a Gully Erosion Site, Asase, North Bank, Makurdi, Nigeria

Malum Japhet Flayin^{1*}, Burbwa Annord Kuma², Sini Vaisa Jonathan³
¹²³Department of Agricultural and Environmental Engineering, Joseph Sarwuan Tarka
University, Makurdi, Nigeria

D.O.I: 10.56201/ijaes.v8.no4.2022.pg38.52

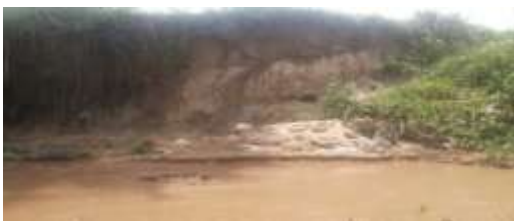
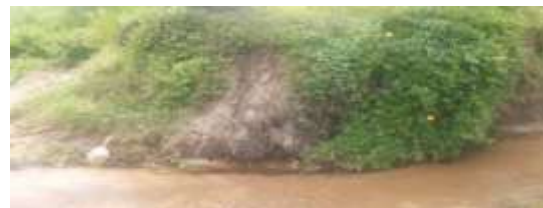
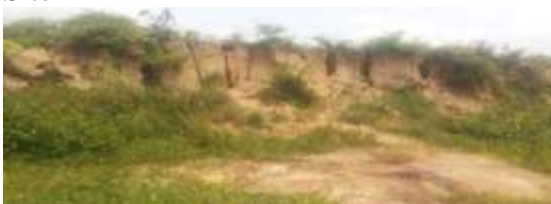
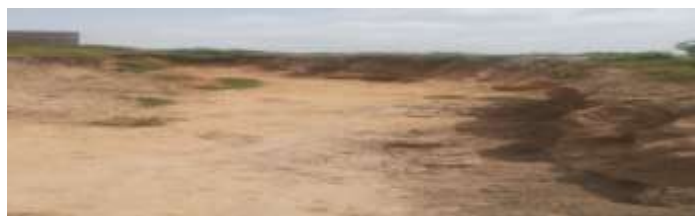
Site E
Plate 1: Gully Erosion Sites from Study Area

Reconnaissance survey of the areas affected by gully erosion was done. Field measurements of morphological parameters of the gully of length, width and depth was carried out and recorded manually. The distance from Asase village (beginning of gully erosion site) to the river Benue embankment was 4km (MLSM, 2017). The study area from the starting point (Asase) to the end point (river embankment) was divided into 5 distant points A, B, C, D and E respectively (Plate

1). The slope and depth of the gully which varied at various study points were measured and recorded using relevant standard field instruments.

The erosion characteristics of the study area gives divergent dimension from site A, B, C, D and E with respect to length (in meters) as 33.07, 120.89, 22.67, 56.10 and 45.03 respectively, width as 29.05, 12.01, 12.85, 25.50 and 25.66 m respectively while their depth (in meters) were found to be 2.60, 3.40, 2.07, 2.80 and 1.82 m. All type of erosion in the 5 sites were found to be gully erosion. The gully length, width and depth varied considerably along the course of the seasonal river that empties into river Benue. The non-uniformity of the erosion characteristics gives an idea that soil characteristics throughout the gully length in the study area are not uniform.

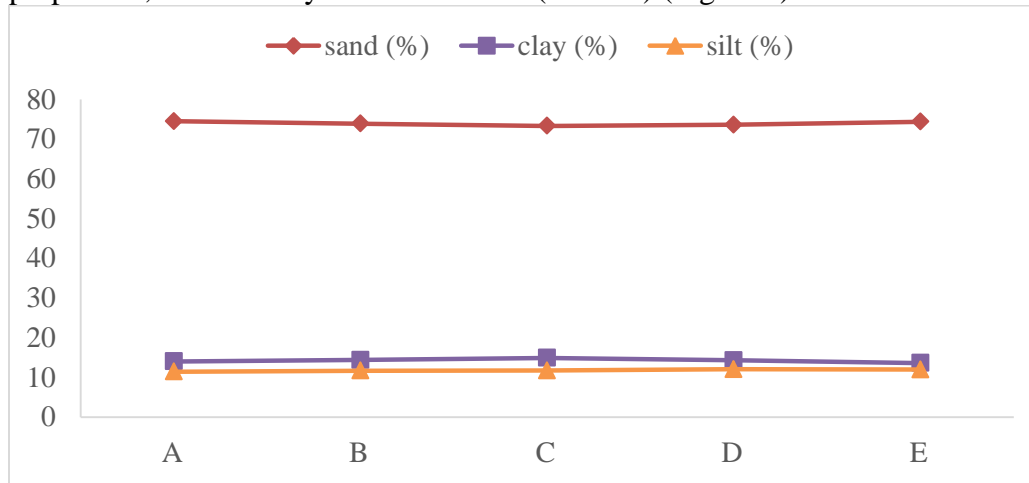
Figure 2: Grain sizes analysis of Soils from the study sites

Physical properties play an important role in determining soils suitability for agricultural, environmental and engineering uses. The supporting capability, movement, retention and availability of water and nutrients to plants; ease of penetration of roots of crops, and flow of heat and air are directly associated with physical properties of the soil. The soil textures were dominated by sand. Thus, the mean particle size distribution of the soil texture along the five sampled gully sites were found as follows: gully Site (A) has mean soil fraction of 74.51% sand proportion, 14.04% clay and 11.45% silt (Table 3) (Figure 2).

The standard deviation was 2.10 for sand, 2.53 for clay and 0.51 for silt while coefficient of variance was 0.03 for sand, 0.18 clay and 0.04 for silt. Gully Site (B) showed a 0.44 for silt while coefficient of variance was 0.02 for sand, 0.11 clay and 0.04 for silt. Gully site (C) has mean fraction of 73.32% sand, 14.94% clay and 11.73% silt; standard deviation for same site showed 2.50 for sand, 1.92 for clay and 0.64 for silt while coefficient of variance was 0.03 for sand, 0.12 clay and 0.05 for silt. In gully Site (D) a mean sand proportion of 73.60%, 14.33% clay and 12.07% silt were analyzed. Standard deviation for same site was 2.19 for sand, 2.25 for clay and 0.20 for silt while coefficient of variance was 0.03 for sand, 0.16 clay and 0.02 for silt respectively. In gully site (E) the mean fraction of 74.36% sand, 13.64% clay and 12.00% silt respectively, were found. Standard deviation for same site showed 1.35 for sand, 1.35 for clay and 0.00 for silt while coefficient of variance was 0.02 for sand, 0.10 clay and 0.00 for silt. Particle size distribution, specifically clay and silt fraction have been found to have good relationship with specific surface area, soil compatibility and compressibility, (Danladi and Ray, 2014), all of which affect inherent productivity of the soil.

The implication of these findings is that, with high proportion of sand at the top layer, percolation and infiltration is high, while low infiltration at the bottom layer is due to high proportion of clay content. This might have increase the falling and slumping of gully walls, (Mbaya *et al*, 2012), from the top and middle of the gullies. Moisture contents mean values for the five sampled gully sites (A to E) was 11.58%, 12.33%, 10.33%, 11.58% and 10.50% respectively (Table 3). This implied low values when compared with standard rating tables for

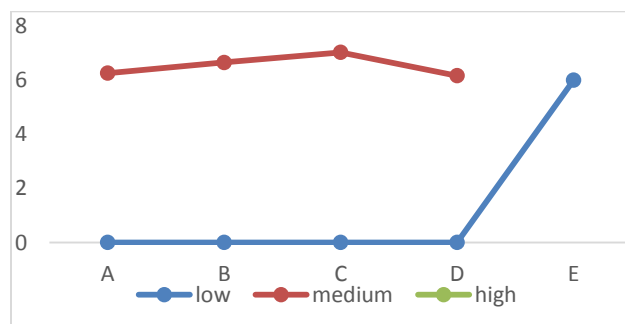
Figure 3: Exchangeable Cations (CEC) of the Study Area

The cation exchangeable capacity (CEC) is the total capacity of a soil to hold exchangeable cations. The mean values of CEC for the five gully sites range between 5.99 – 7.02. This means that the CEC is medium in the soils of the study area when compared to standard ratings (Figure 3) (Table 5).

The average pH values for the five gully sites ranged from 6.08 - 6.19) (Table 4). These are slightly acidic (Figure 3). The soil there fore may not be affected by micro-organisms that work on organic matter which enhance the binding of soils to resist erosivity from rainfall and runoff impact. Moreover, the gully sites are within residential area which is not a suitable habitat for micro-organisms(Fifield, 2001; Jon and Jackie; 2015; and IR, 2017).
