## Spatial Distribution and Magnitude of Building Setback Violations in Makama New Extension Area of Bauchi Metropolis

**Mahmud, Lawal Mahmud; Oladosu, Rasheed Osuolale; and Idris, Omeiza David**

Department of Urban and Regional Planning

Abubakar Tafawa Balewa University, Bauchi, Nigeria

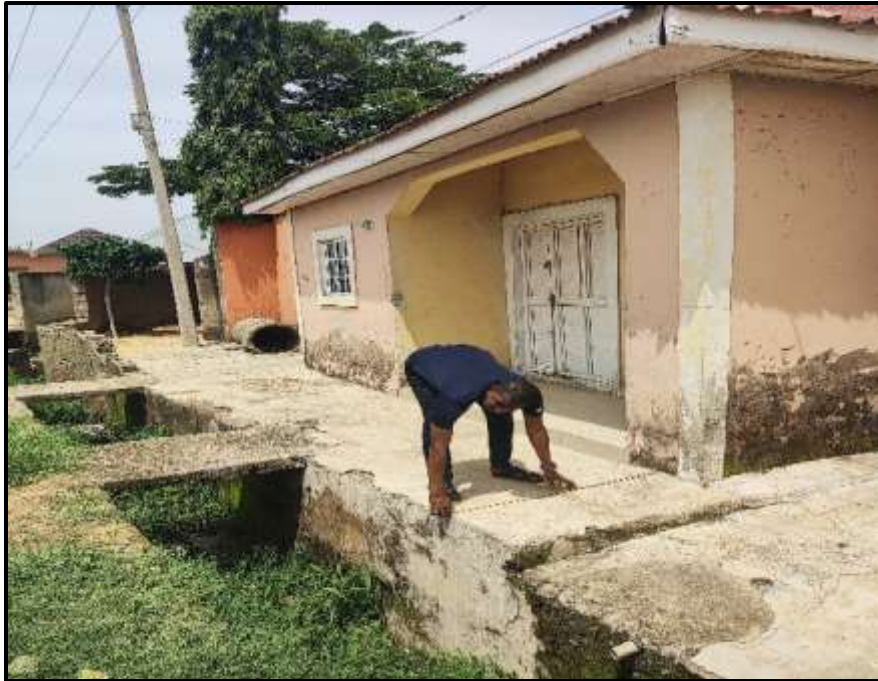
**Figure 5: Front Setback Field Measurement**  
**Source:** Researchers' Field Observations (2026)

Prior to the commencement of the data collection, official approval was obtained from the Bauchi State Physical Planning and Development Control Board (BSPPDCB) to gain access to relevant records and maps. A reconnaissance visit was conducted to familiarize the researchers with the study area and make the necessary logistic arrangements for the exercise. Violated buildings were then identified, and permission was sought from the household heads before the setback measurements were taken on individual properties (Figures 5- 6). The front, side, and rear setbacks of the buildings in each block were measured using appropriate measuring tapes. The 281 copies of questionnaires were administered daily between 9:00 am and 5:00 pm by the researchers and five (5) trained field assistants, who were briefed on the objectives of the study and procedures for questionnaire administration to ensure consistency and accuracy. The field assistants were assigned specific blocks within the study area and provided with sampling guides and measurement tools. For data analysis, QGIS was used for the spatial distribution of building setback violations while mean score analysis and one-sample t-tests against the prescribed standards of 5m, 3m, 1.5m and 1.5m were used to determine the magnitude of building setback violations.

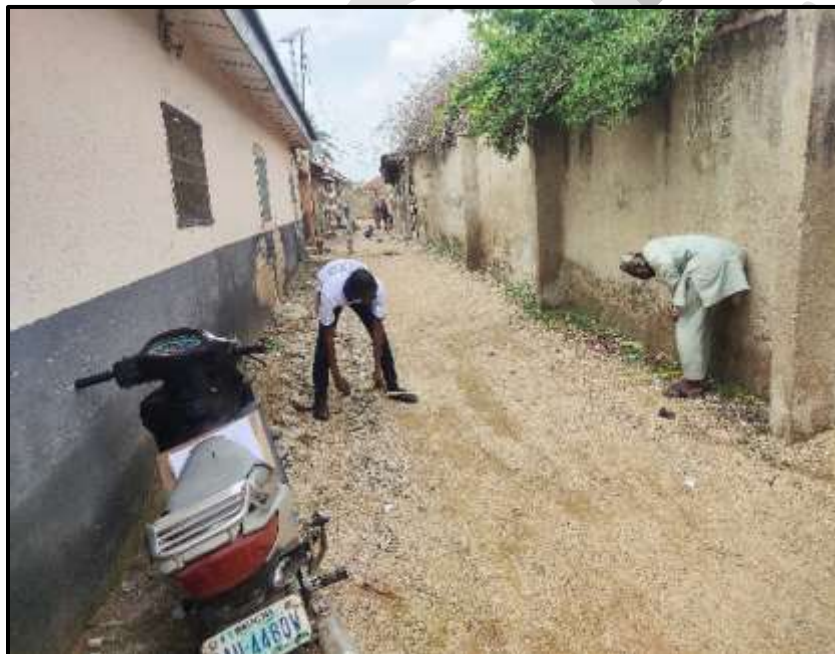
**Figure 6: Side Setback Field Measurement**  
**Source:** Researchers' Field Observations (2026)
