## A Spatial Assessment for the Extent and Severity of Gully Erosion in Dawakin-Tofa LGA, Kano State

*An integrated approach with Geographic Information Systems (GIS), fieldwork techniques and secondary data was adopted to assess the severity and map out the spatial extent of the menace of gully erosion in Dawakin-Tofa Local Government Area. The coordinates of 19 gully sites were taken and imputed into a GIS environment (ArcGIS 10.2) to show the distribution of gully sites. Landsat TM, Quickbird and SPOT V Satellite imageries were processed and interpreted to produce spatial extents of three major gully sites; Rarun in Dawakin-Tofa, Romi gullies and 'Yan Shado in Marke. The Digital elevation model (DEM) was used to show how topography affected gully erosion in the area which showed patterns related to various land use practices as well. Over a six year period, area of gully profiles in Dawakin-Tofa range between 0.5 km<sup>2</sup> in 2008 to 6.2 km<sup>2</sup> in 2014, representing an increase of 5.7 km<sup>2</sup>. Gully depth also witnessed increase from 6.1m to 11.8m leading to devastating consequences on roads, farmlands and vegetation. Field survey revealed abstinence from gu

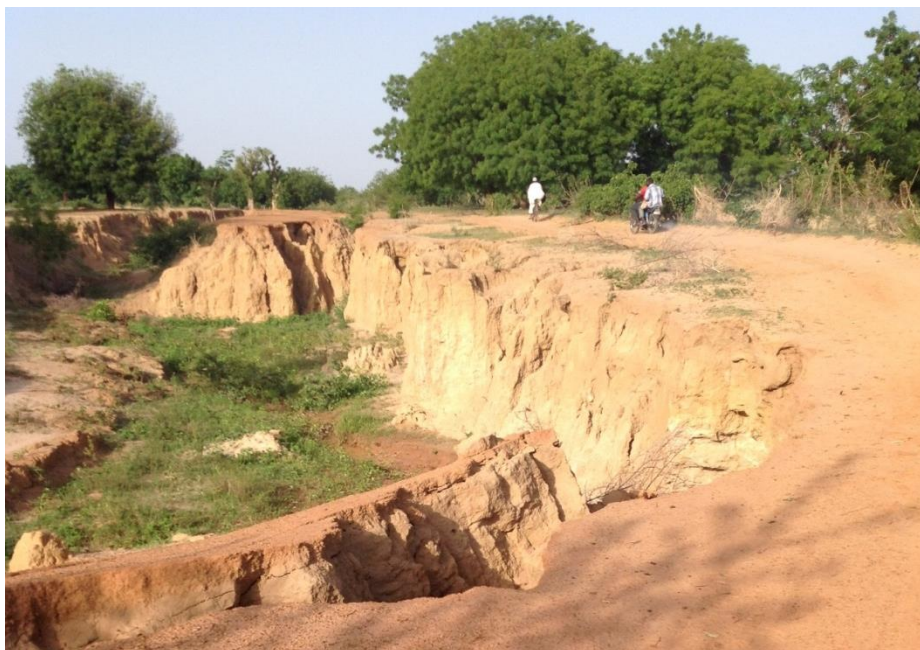
**Plate 2: Sections of the Romi Gully site**  
Source: Fieldwork, 2017

The second most severe gully site in dawakin-Tofa Local government is the one in Romi covering a spatial area of 3.7 km<sup>2</sup>. Its length is roughly half a kilometer and it has consumed the major road linking the village to the local government headquarters.

The Kano State and Dawakin-Tofa Local Government should employ immediate erosion controlling measures for areas that suffered severe erosion. Control measures such as land filling, immediate planting of some of trees and vegetal cover should be taken to stem the spread. Also other less forms of erosion should be checked preventing further degeneration.

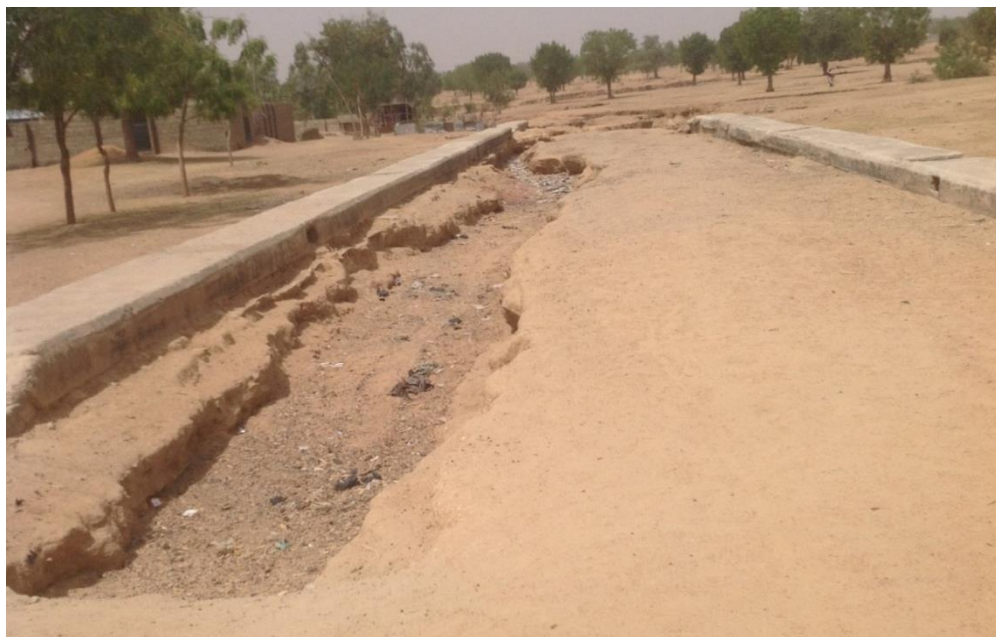
**Destruction of Roads and Transport Infrastructures:** many roads have been destroyed by gully erosion and a handful of others are seriously threatened.

**Plate 4: The on-going 5 kilometre road in Dawakin-Tofa town been encroached by gully erosion.**

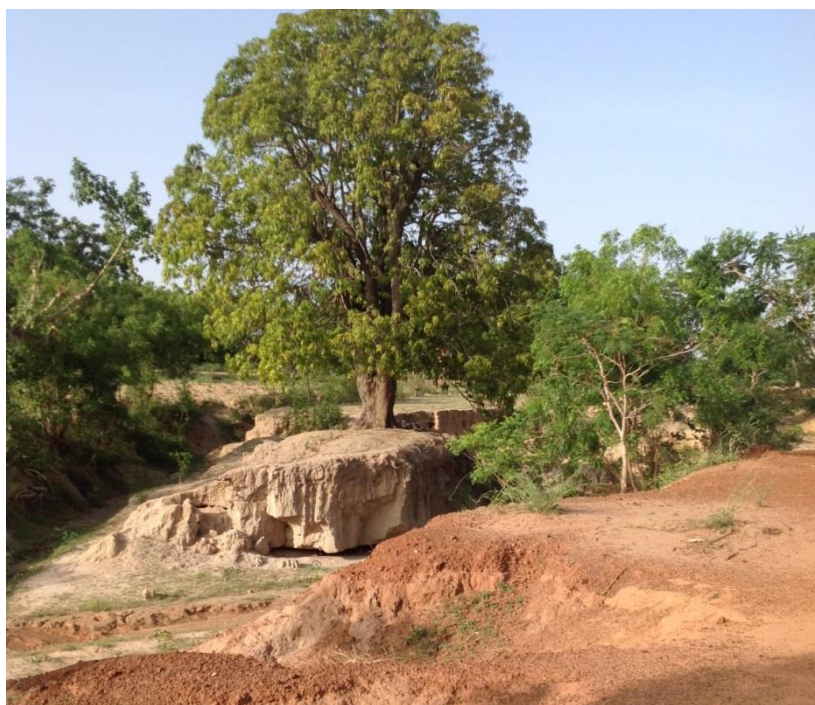
**Destruction of Vegetation:** trees are threatened by gully erosion as many were found to have collapsed due to the impact of the gullies.

**Plate 5: Trees threatened by gully erosion in Romi**
