Solid Waste Management, Surface Water Quality and River Basin Contamination in Akwa Ibom State: Case Study of Ikpa River Catchment

Abraham, C.M, Ukoh I.J & Jimmy, U, Bassey, I.O
Department of Geography and Natural Resources Management,
University of Uyo, Uyo
Email: jimmyutibe21@gmail.com
DOI: 10.56201/ijssmr.v10.no11.2024.pg.263.283

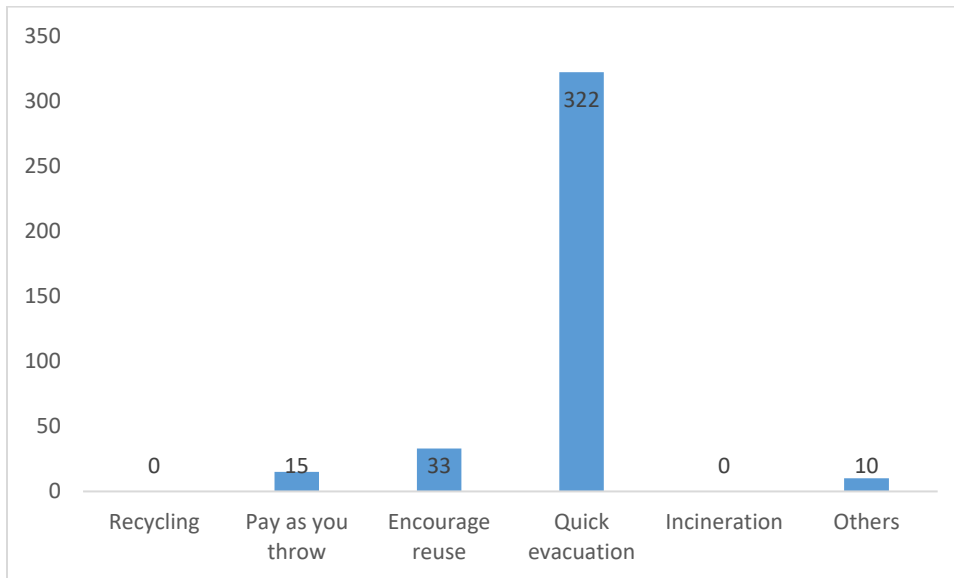
Figure 4.1: Waste Management Strategies in the Study Area

Figure 4.1 shows that within Ikpa River Basin, waste management strategies are very poor (see plate 1). Respondents only rely on quick evacuation of waste from their neighbourhood.

The second most adopted strategy is encouraged reuse and pay as you throw. Recycling and incineration are completely 0% in the study area which shows the poor extents of waste management in the study area. Consequently, it can be concluded that the extent of solid waste management in the study area is very poor.

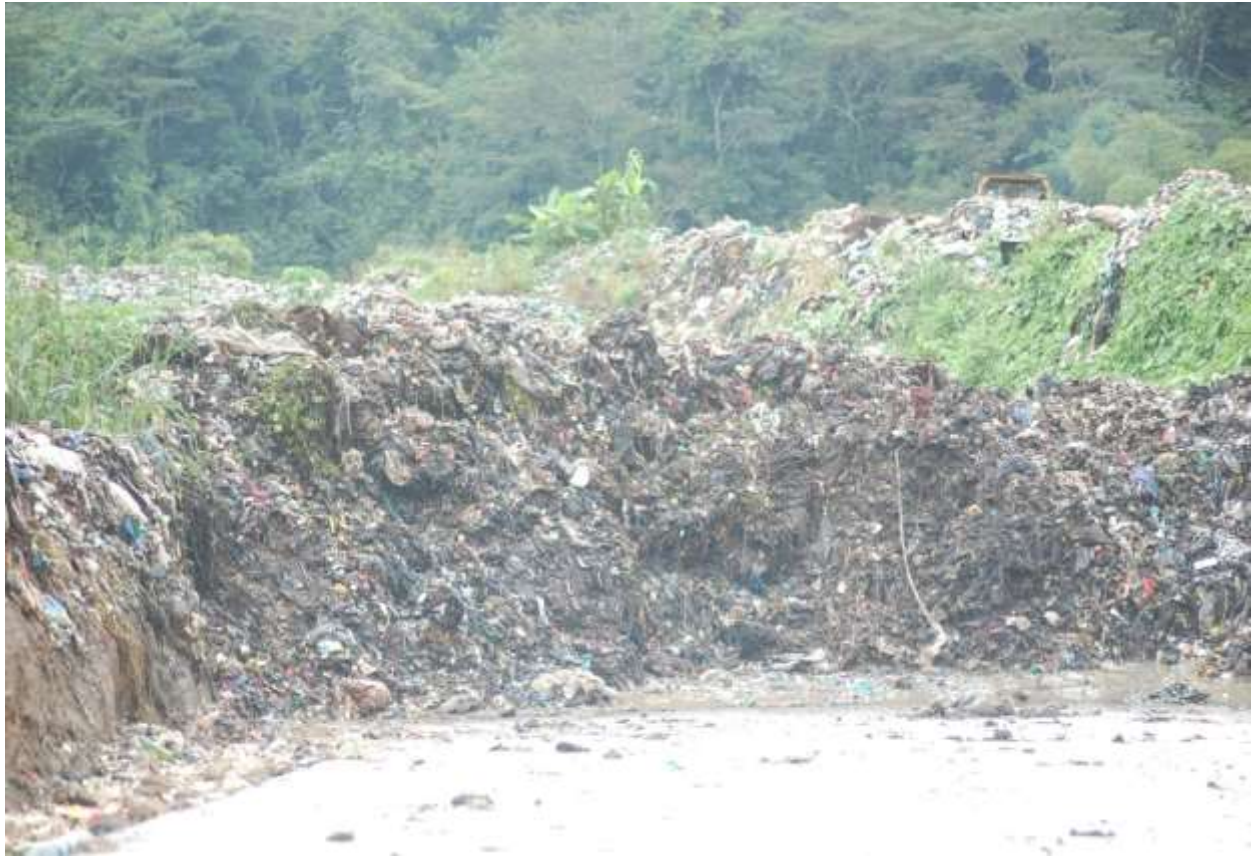
Plate 1: Waste Degraded Environment at Uyo Village Road

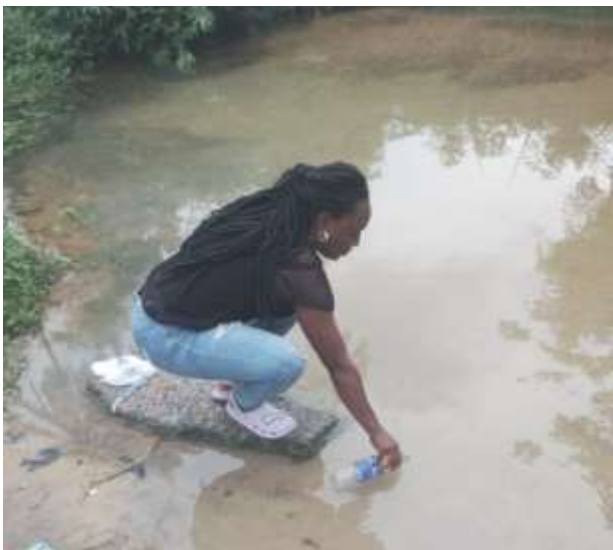
Plate 1: Water sample collection

The grab and composite sampling methods (Rao, 2004 and Metcalf, 2003) were used in collecting water samples from the surface water at various locations. One-liter, transparent plastic bottles, labeled according to locations, were used in collecting the samples for physical and some chemical parameters analyses. The bottles were placed in a cooler box, to prevent them from being disturbed, and transferred to the laboratories for further analysis. On the other hand, samples were preserved during storage before laboratory analysis as recommended by Ademoroti, (1996).
