# River Depth Alterations Resulting from Intensive Mechanical Dredging of Ekole Creek, Nun River Bayelsa State

Simon Churchill E.<sup>1</sup> and Ogunlowo Opololaoluwa O.<sup>1\*</sup>

<sup>1</sup>Civil Engineering Department, Faculty of Engineering, Federal University Otuoke, Otuoke, Bayelsa State, Nigeria. +234(00176-0000), Ogbia (562103).

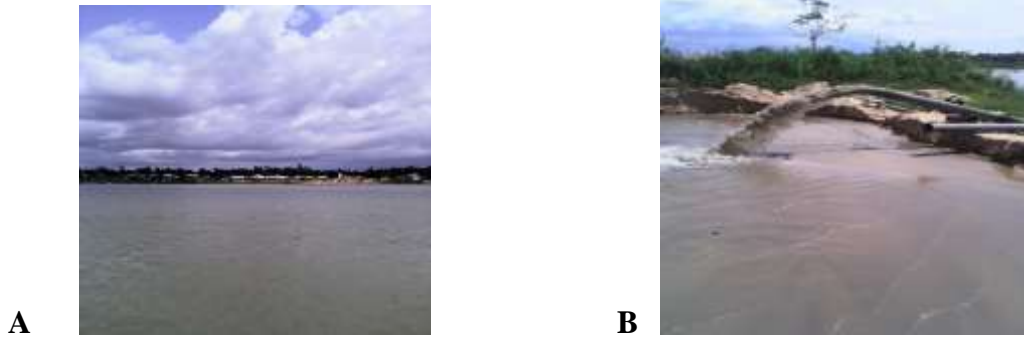
**Plate 1** (a) Pictorial View of Coastal Communities and Creek Bayelsa State (b) Active Dredging in Ekole  
*2.2 Hydrographic Survey*

The location of the study is around Yenagoa where Famgbe, Akaba, Ogu Ikasikara, Otuegwe, Otuogori and others as mentioned above are included, and all located in Ekole Creek’s bank of Nun River. Yenagoa the capital city of Bayelsa State in Nigeria. Its geographical demography is within latitudes  $4^{\circ}49'N$  and  $5^{\circ}23'N$  and also within longitudes  $6^{\circ}10' E$  and  $6^{\circ}33'E$  [8]. Ekole creek is one of the major river courses making up the Niger Delta’s river as indicated in (Figure1.0), which is located within the lower delta plain, [9] with mean annual maximum temperature range of  $31.5^{\circ}C$ - $33.84^{\circ}C$  as observed in the period from November-March, while the mean minimum temperature ranges from  $28.8^{\circ}C$ - $29.46^{\circ}C$  [10]. Plate 1.0 also shows the Pictorial View of Coastal Communities and Active Dredging in Ekole Creek.

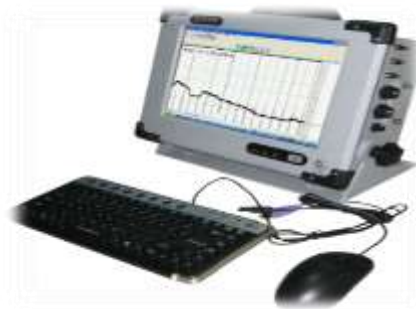
**Plate 2** Specifications and Features of SDE-28S Digital Echo Sounder

Hydrographic survey team used an echo sounder which was installed on a speed boat and driven across the width of the creek. At each sampling point, echo sounding was done across the width of the approximately 270 m wide river and observations recorded using SDE-28S Digital Echo Sounder as shown in plate 2.0.

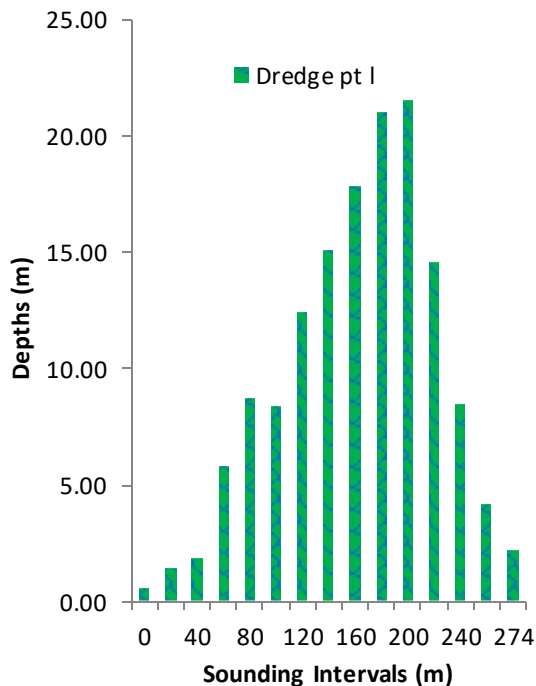
Figure 3.3 Depth Variation at Dredge point I

At Dredge points I and II however, there was a sharp increase in depth where dredging activities were on-going. This depended on the type of dredger, technique, duration and magnitude of dredging operations in the area. Dredge point I showed a very sharp and unbelievable depth variation, where the shallow point was 0.5 m while the deepest part was 21.5 m as shown in (Fig. 3.3) and that of Dredge point II showed a much lesser value of 17.73 m as its maximum depth as show in (Fig. 3.4) below.

Generally, the depth at Dredge point I was highest (21 m) followed by that at Dredge point II (17.73 m) and downstream points (12.7 m). This indicated that alterations had been made to the bottom profile of Ekole creek as a result of dredging activities.
